Manhole Inspection Summary

Manhole # S31AA1002MH

Insp Date: **5/29/07 4:49 PM**

Location Address: **SAN MARTIN DR**

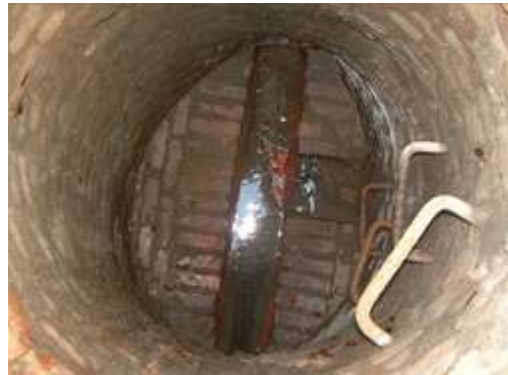
Top View

Corroded steps. Evidence of surcharge - Bench debris. Channel debris.

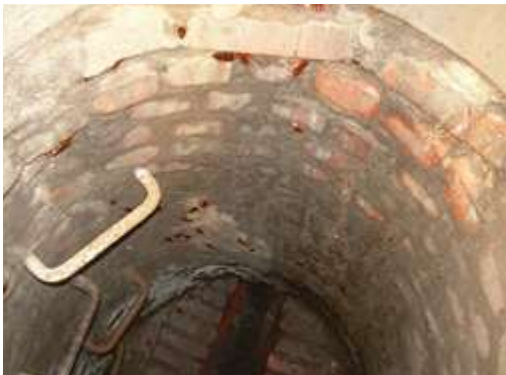
Defect

Frame leaks. Corbel and Barrel infiltration.

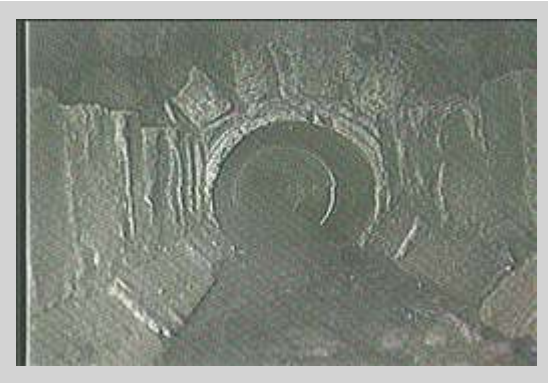
8 in. Circular Gravity Sewer Pipe Out @ 12 O'Clock

Channel deterioration.

Infiltration: **Evidence** Pipe Seal Cond: **Cracked**

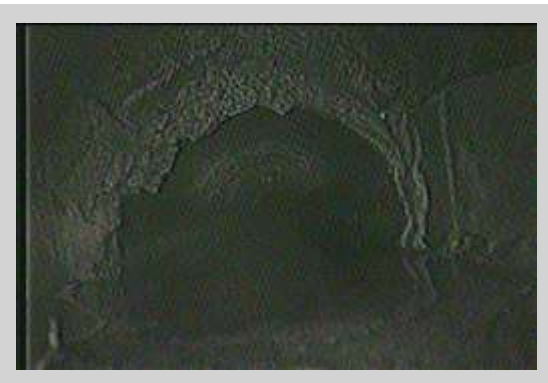
8 in. Circular Gravity Sewer Pipe In @ 3 O'Clock

Infiltration: **Evidence** Pipe Seal Cond: **Cracked**

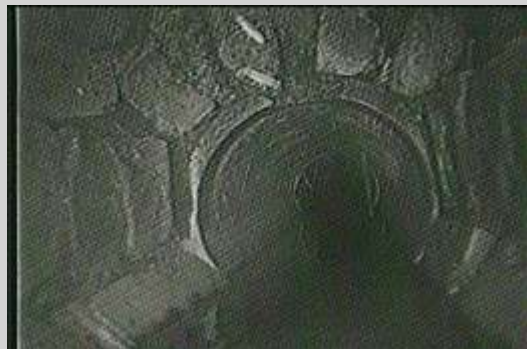
Pipe In @ 6 O'Clock

Infiltration: **Evidence**

Pipe Seal Cond: **Cracked**
